A TOWER HOUSE AT YENİ FOÇA İZMİR

Location, owner, and use

General description

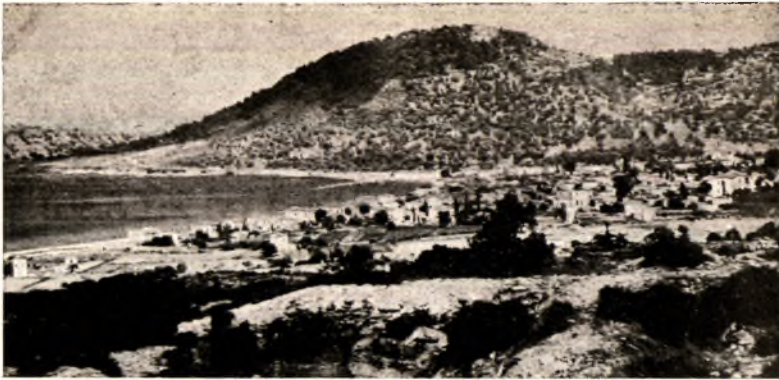
a. The town of Yeni Foça from the south. The tower house lies close to the sea at the extreme left of the picture.

The plot lies to the south of the coastal road, about two hundred metres from the sea. (Pl. I, a) A metal plate bearing the number 746 is fixed to the east wall of the tower to the left of the door. This number would appear to be the only 'address' that the tower has.

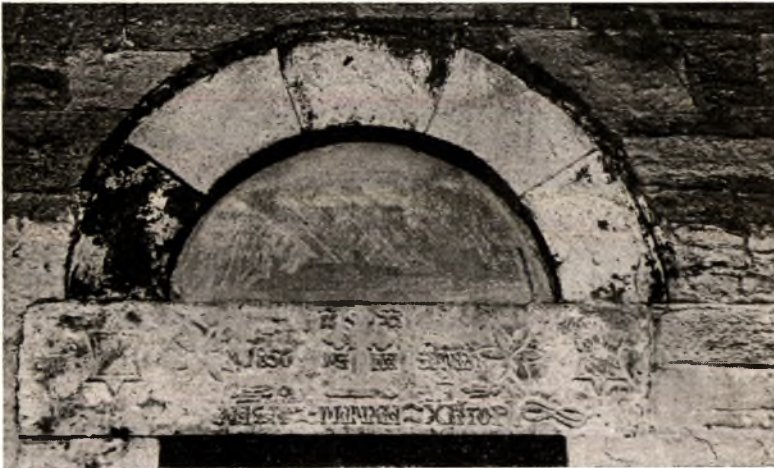
b. Lintel and arch over the door.

From the inscription over the door (see fig. 9 and Pl. I, b) we can read the builder's name and the date 20 IOYNIOY 1850. The bottom line of the inscription reads: ΑΝΑΓΑC ΜΑΝΟΥΙΛ ΧΗΤΤΟΡ (XHTHTOP) ἀνάγας: n. from the Greek verb, ἀνάγω: to lift up, erect or raise. Μανουήλ is a shortened form of the common Greek first name Ἐμμανουήλ: or Emmanuel. Χτήτωρ: n. is a variation of Κτήτωρ: n. formed from the verb κτίζω or κτήζω: to found, build, or create in an artistic sense. Thus we may say that Emmanuel Anagas (or Emmanuel the Builder) built this house in 1850, presumably finishing it on June 20.

Apart from the date and the name of the builder, the incised lintol over the door (see Pl. I b, and fig. 9) also bears the following details carved in intaglio.

At each end of the stone is a roughly carved six-pointed star. The πεντάλφα or pentacle of the Pythagoreans is still regarded as a good luck sign in modern Greece (a five pointed star enclosing a pentagram) but I have not been able to attach any special importance to the use of six pointed stars. On a carved wooden panel of the 'Sultan's box' in the early thirteenth century Ulu Çami at Divriği, a chain of these stars is used to form the border enclosing a carved arabesque. I have also noted the use of this six pointed 'Star of David' or 'Muhr-i Solaiman' as it is known to the Moslems, as a decorative motif in a number of early Ottoman mosques in western Turkey. In Tire for example I have seen it used to decorate the side panels of a marble 'mimber.'

Next to each star and nearer to the centre of the stone is a flower motif. The left hand motif has four bifurcated petals, the right hand motif has six plain petals.

In the centre of the stone is cut a cross fleury with rays coming from its centre, the whole standing on a mound or base.

In the spaces between the arms of the cross is cut the familiar legend: ΙΕ ΧΣ ΝΙ ΚΑ: Jesus Christ Conquers.

Three birds are depicted flying singly towards the left of the stone (southwards in this case — has this any significance?)

The spacers between the words ΑΝΑΓΑC, ΜΑΝΟΥΙΑ and ΧΤΗΤΟΡ are in fact pairs of dolphins (again regarded as good luck symbols in modern Greece). Finally the device at the bottom right hand corner may represent a knot or an infinity symbol, both of which would presumably signify 'permanence.'

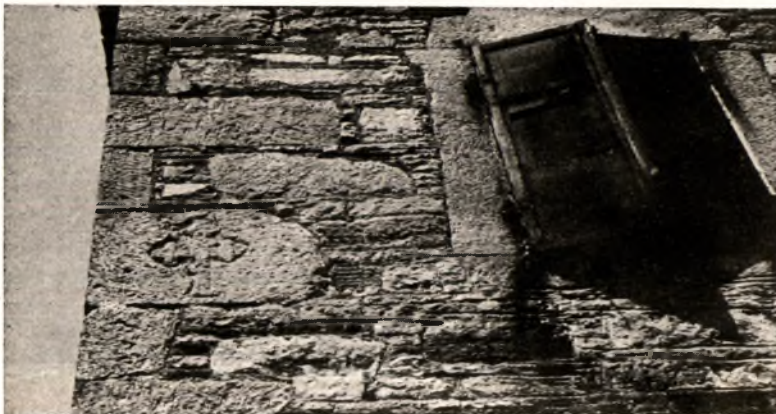
c. Cross carved in quoin block at southern edge of east wall.

At the southern edge of the east wall at a height of over four metres from the ground there is another cross fleury also carved in intaglio into a quoin-block. (See Pl. I c).

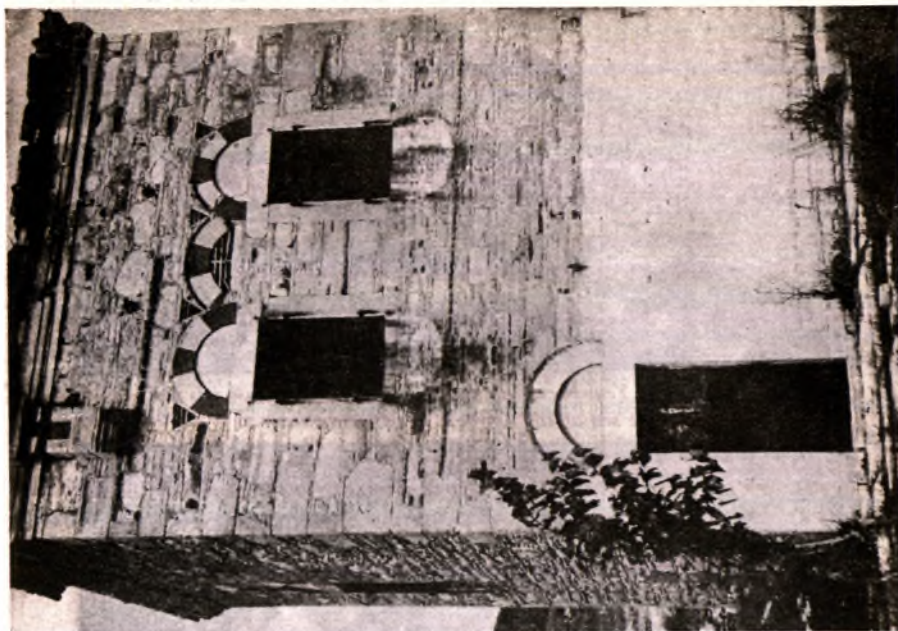
b. East elevation

A further feature of the north, east, and south facades, is the use of tile slips, bricks, and red stone to produce decorative panels and coloured bands. (See Pl. I b, Pl. II b, Pl. III a, b). Triangular panels filled with diagonal and horizontal lattices executed with tile fragments and slips of stone are set into the north, east, and south walls above the level of the first floor windows. Tile and stone 'roundels' also decorate the same walls above the level of the triangular panels. These 'roundels' are formed by setting a terracotta waterpipe into the wall and then arranging a series of tile and stone slips to radiate spokelike from the circular hub thus formed.

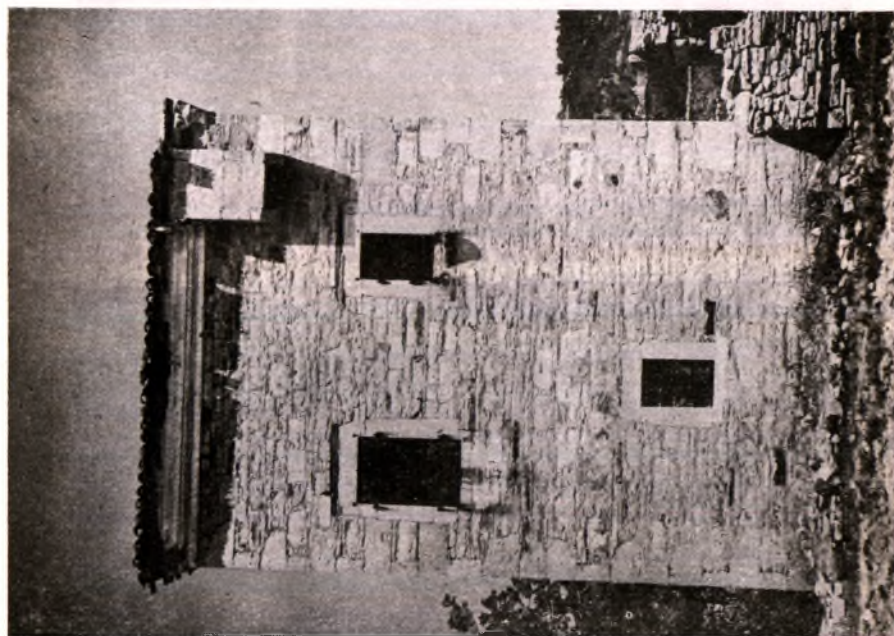
a. West elevation

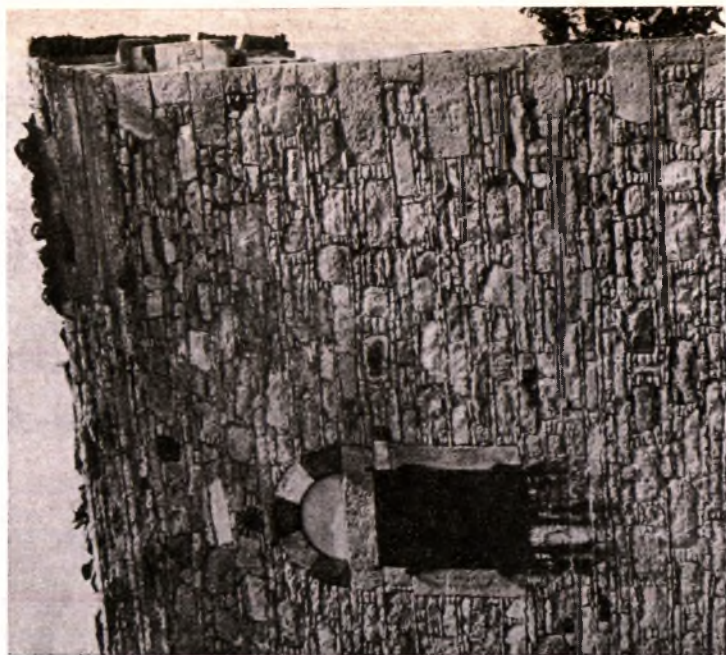
b. South elevation

both reach the outer face of the wall at the level of the stucco cornice. (See Pl. III b, and fig. 5). At present the cornice stuccowork does not cover the ends of the pipes although at one time it may have done so.

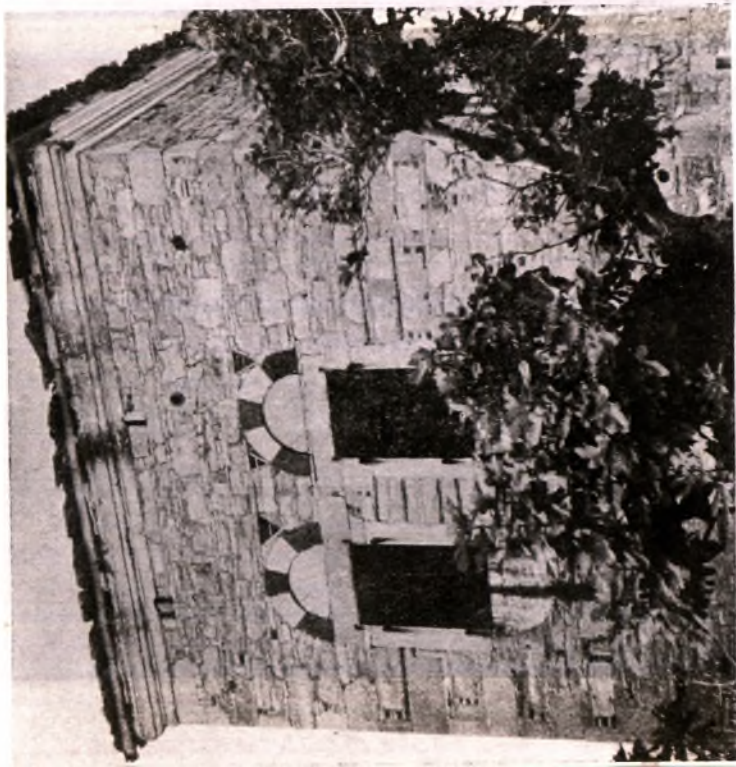
a. North elevation

The embrasures pierce the west, north, and east walls of the loft, and are only visible from the outside as small slots about 5 cms. wide and just under 20 cms. high, positioned immediately below the stucco cornice. (See Pl. III, a and fig. 5).

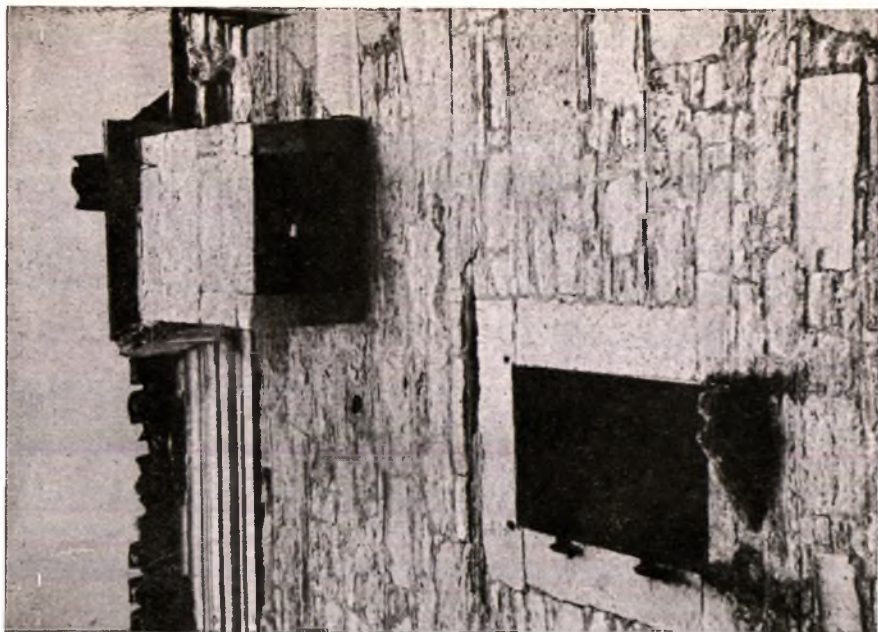
b. West elevation: looking up at the underside of the latrine and the water spout which drains the sink.

The first floor living room has more generously proportioned windows. Five of the seven windows to this room have semi-circular arched embrasures. The remaining two, on the fireplace wall, have flat wooden soffits. The window embrasure between the head of the staircase and the fireplace, contains the shallow stone sink which is drained via a hole beneath the window frame. Water from the sink runs through the hole and is then discharged into a ditch below by means of a roughly shaped stone water spout.

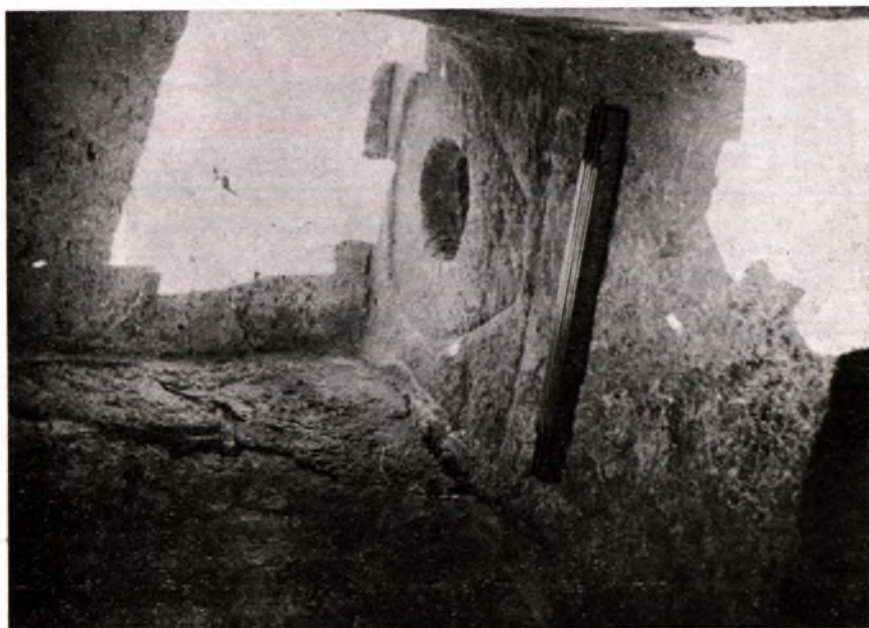
a. Latrine in loft after cleaning

The western one (the larger of the two) is in fact a latrine with an unmistakeable recess for a wooden seat cut into its perforated stone base slab. (See Pl. IV, a). The nail driven into the wall on the left hand side of this recess has already been suggested as an anchor point for a rope. It is possible that it served as a hand grip to assist anyone trying to get out of this restricted space after having first managed to back into it. (The nail has an 8 mm. square shank and protrudes some 7 cm. or more from the wall face).

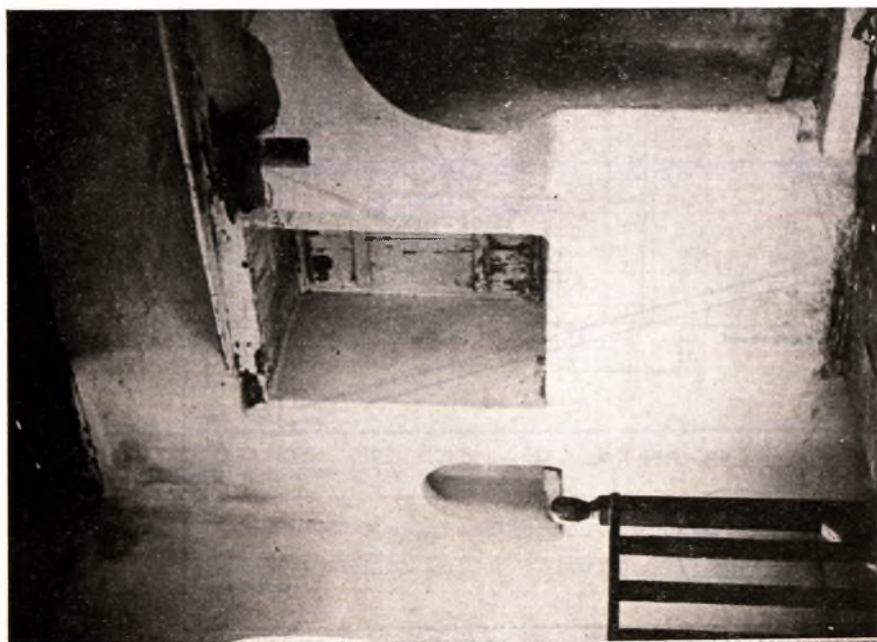
a. Interior of the first floor room looking towards the head of the staircase. The entrance to the loft may be seen in the upper left hand corner of the picture. The leading to the pot hidden in the chimney is just out of view above the arch over the fireplace.

To gain the first floor, or main living room, one has to cross the mezzanine platform to the south wall, and ascend a wooden stair of nine treads. The living room is then identifiable by its large fireplace, two fitted cupboards, and a small sink which has been cunningly contrived in the sill of a window embrasure. (Fig. 3).

If one then examines the wooden ceiling of the living room, a hatch may be observed which lies directly over the staircase. The loft, which one enters via this hatch, once had a boarded floor which has now disappeared. (I was only able to get into the loft by using a borrowed three metre ladder. The original means of access must have been by a similar ladder or perhaps even a rope. The large hand-wrought iron nail which is driven into the wall adjacent to, and above the hatch, may have been for the purpose of attaching such a rope. See below).

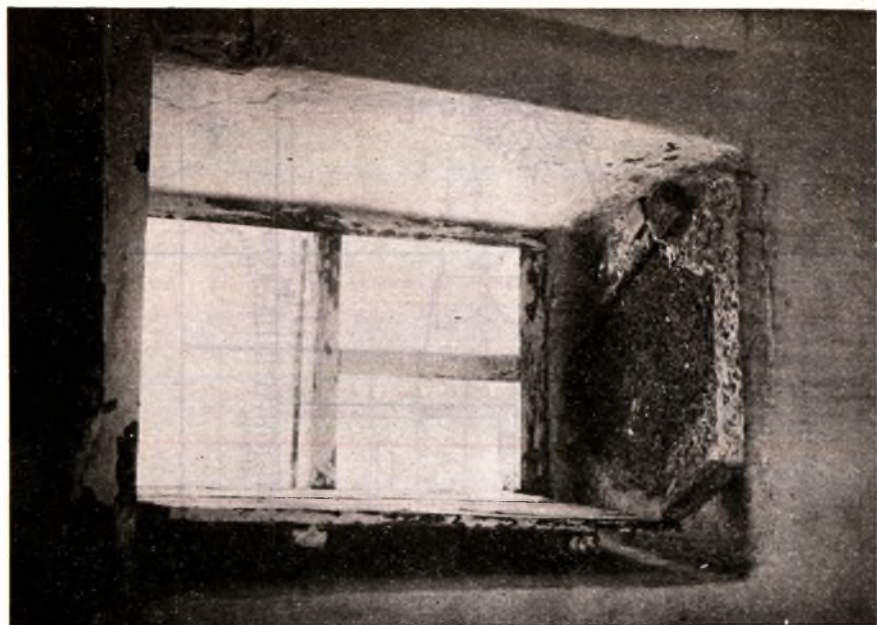
b. The sink in the window embrasure.

Only the window over the sink retains a complete unglazed wooden, window frame in addition to its externally hung shutters. The frame has a single transom, and one muntin in the lower half of the opening. There is also a single leaf inward opening wooden shutter. (See Pl. V, b). All the windows retain their external iron shutters, and most of them still have parts of their subframes of timber. Apart from the window over the door, the windows lack further evidence for opening lights. The window over the door has sufficient woodwork left for the marks of hinges to be seen. These suggest that each window once had casements (The marks indicate that the hinges were of the 'butt' type). The bars of the fixed light over the sink have no rebates for the insertion of glass, nor are there any traces of beads or battens which might have served the same purpose. I have therefore assumed that oiled paper or cloth may have been used in lieu of glass. There is a strong possibility that the casements only had muslin stretched across them, with the idea of keeping out the mosquitoes rather than the elements. (The house stands on low ground which is subject to flooding. Having slept in a nearby house I can testify to the voracious appetite of the mosquitoes from the adjacent stagnant water.)³ The loft has no windows or light openings other than the musket or pistol loops mentioned above. The latrine hole admits some light, and a very slight amount is admitted by some terracotta water-pipes which are set into the south wall.

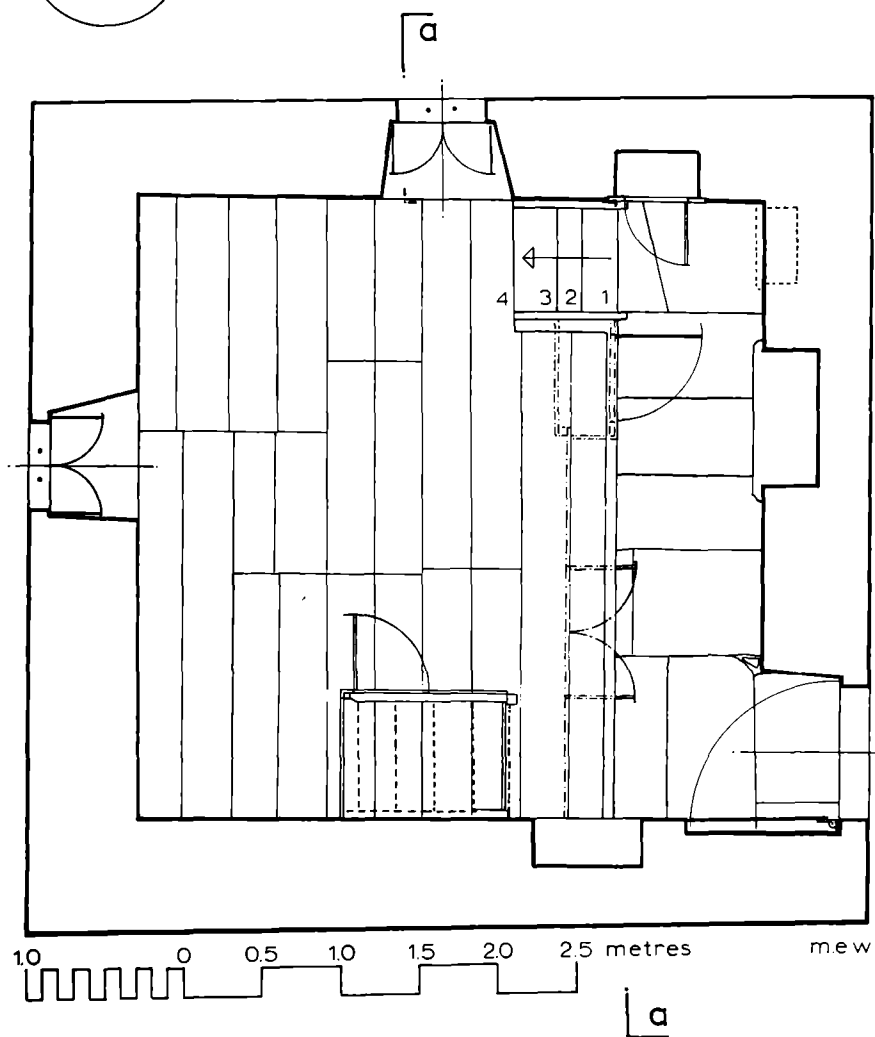
Fig. 2 Ground floor plan.

tower house at Yeni Foça. İzmir.
ground floor plan.

The house has three basic storeys. The ground floor is entered via an iron door which is the only door in the building. (Fig. 2) On entering one turns to the right and passes along a passageway between the east wall of the house and a wooden platform which has storage space beneath it for agricultural produce. The platform, which might be termed a mezzanine floor, is mounted by means of a wooden stair of three treads at the north end of the above mentioned passageway.

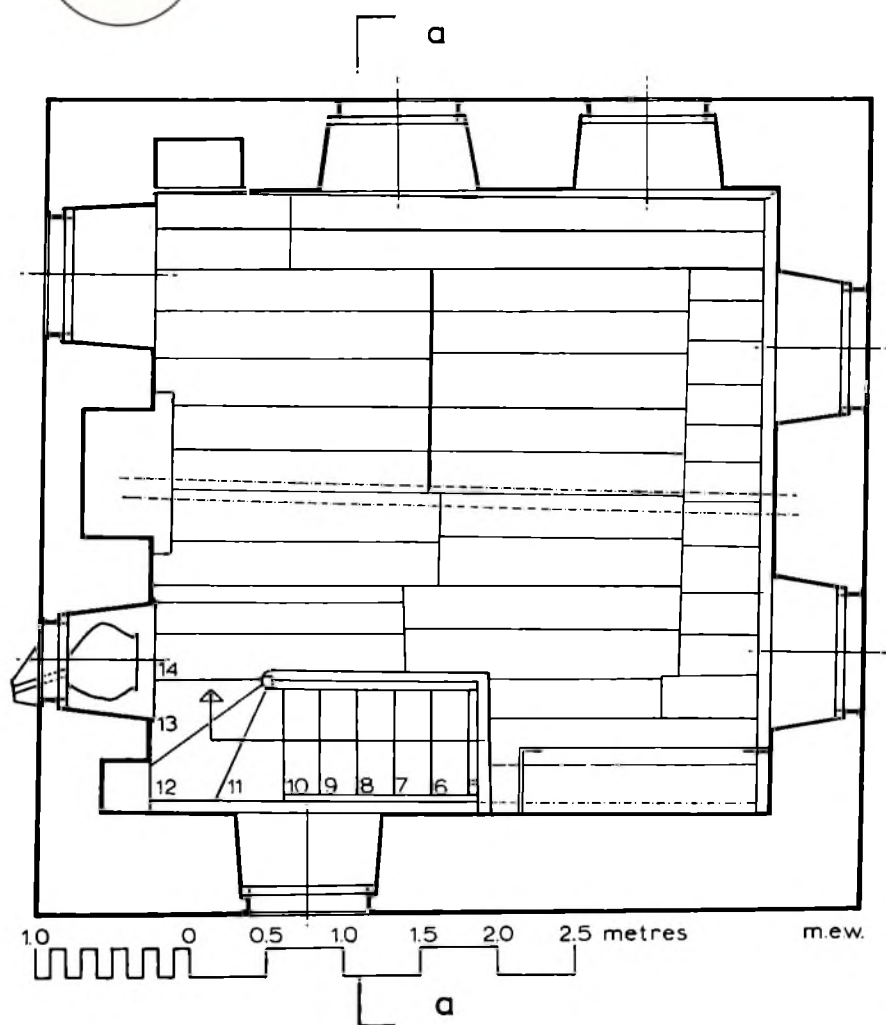
Fig. 3 First floor plan.

tower house at Yeni Foça, Izmir.
first floor plan.

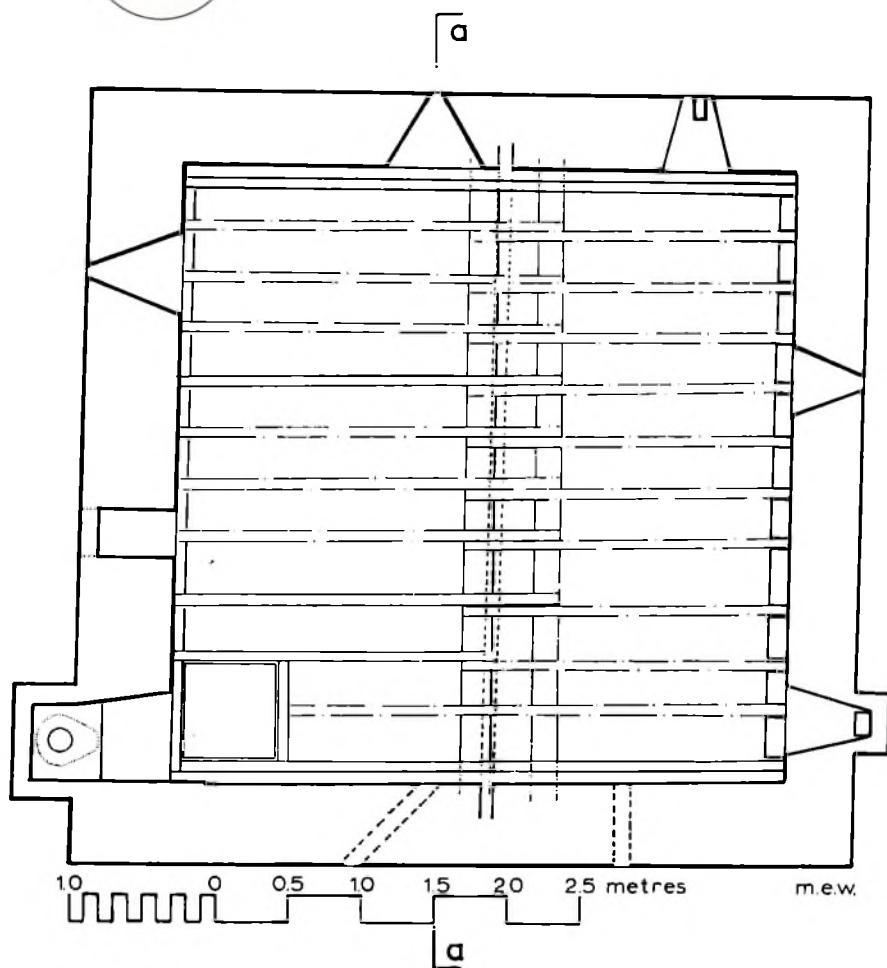
Fig. 4 Loft plan.

tower house at Yeni Foça. Izmir.
loft plan

Once in the loft, a number of tapered embrasures immediately suggest the subject of fortification. (See fig. 4).

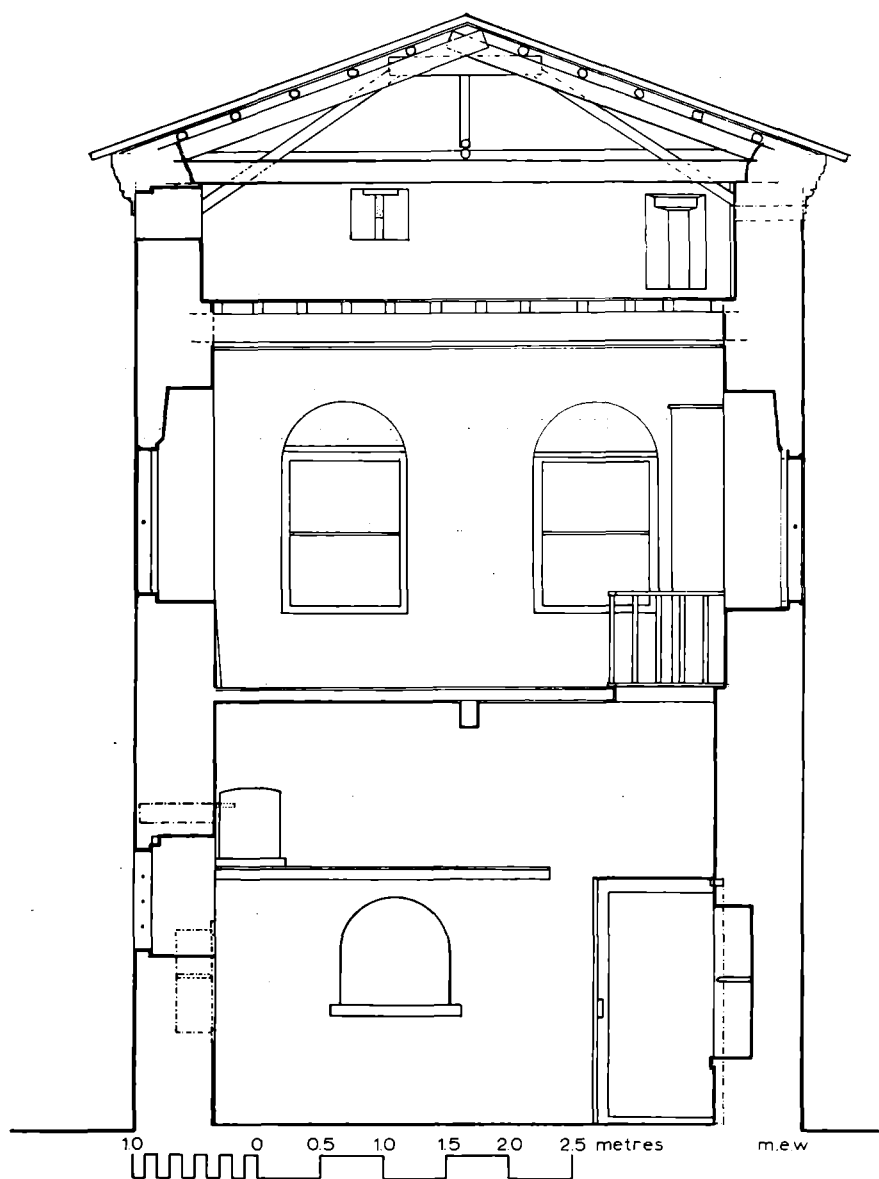
Fig. 5 Section looking east.

tower house at Yeni Foça, Izmir, section looking east. a-a

The roof structure now consists of a couple-close 'truss' combined with a collar and a pair of 'bird's mouthed' collar braces. The couple-close truss consists of two inclined 15 x 7 cm. principal rafters halved and spiked together at their tops, and a 17 x 9 cm. tie beam which connects the feet of the rafters. The whole assembly thus forms a triangle. (See fig. 5).

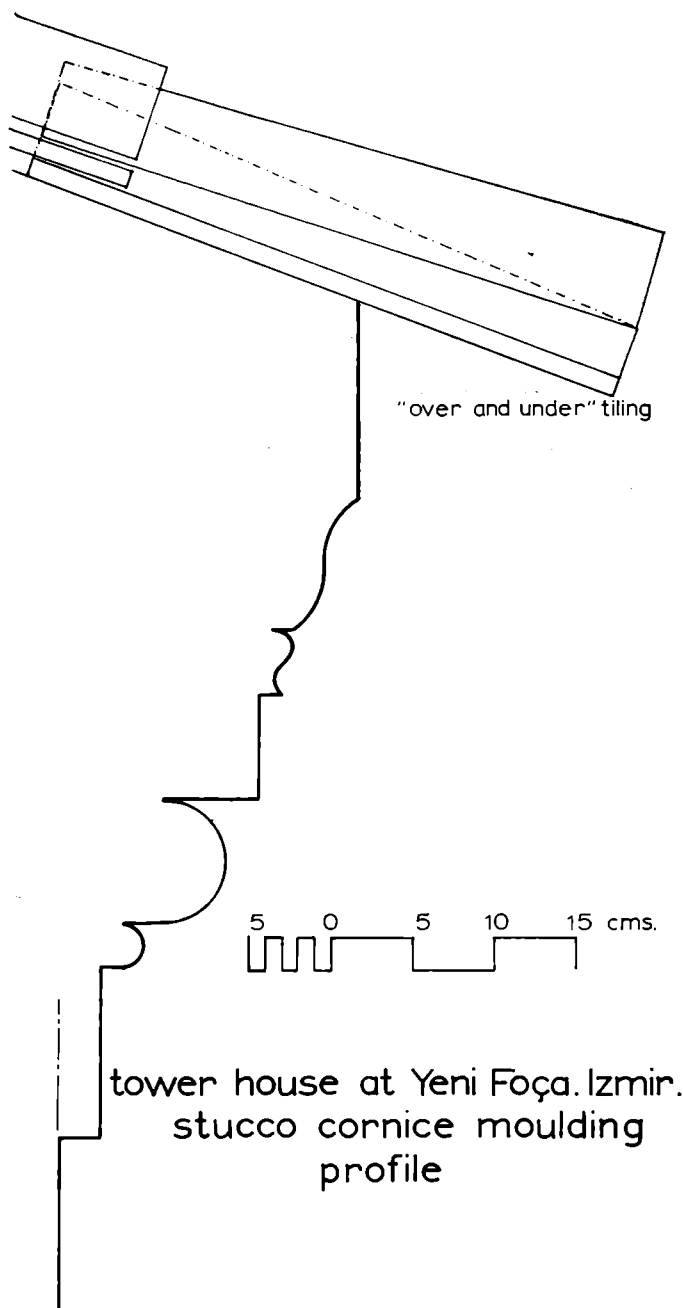
Fig. 6. Stucco cornice moulding profile.

The building has a stucco cornice of a debased classical profile. (See Pl. IV b, and fig. 6).

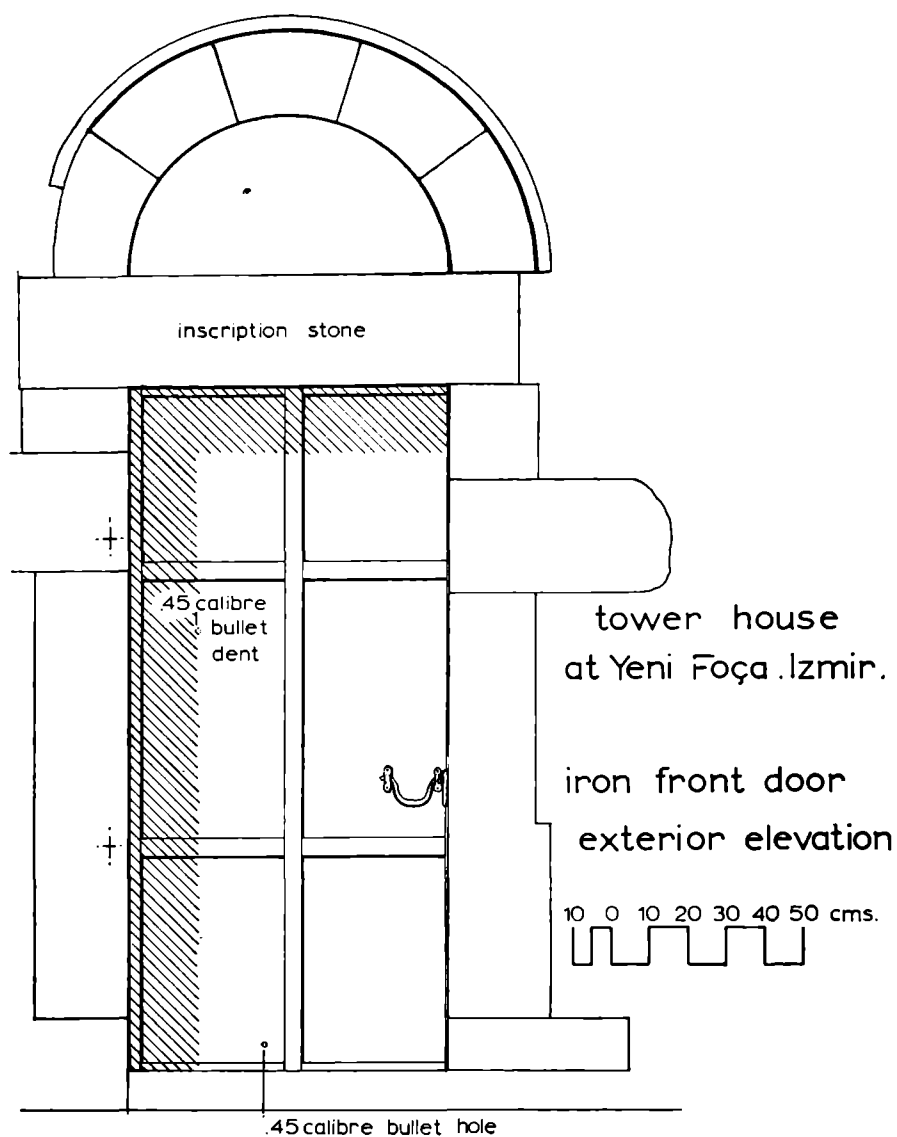
Fig. 7 Iron front door. Exterior.

There are also signs that the door is not in its original state. A timber beam remains embedded in the wall above, and to the south of the door. This beam has a vertical hole in it which was obviously once intended for a door pivot. On the north jamb of the door frame there is a substantial wrought iron 'staple' which would take a large bolt or bar. Although this 'staple' is now disused it could have received the bolt from a lock which is now missing from the door. A large sheet iron patch has been crudely rivetted to the old plate in order to cover the hole left when a lock was torn out. The jagged nature of the hole strongly suggests that the old lock was blown off with explosives.

defensive position has not prevented someone from firing two .45 calibre bullets at the outside of the iron door. One of the bullets penetrated the 3 mm. iron plate, the other made a deep dent. (See figs. 7 and 8). I have not been able to discover any further traces of the bullet which penetrated the door.²

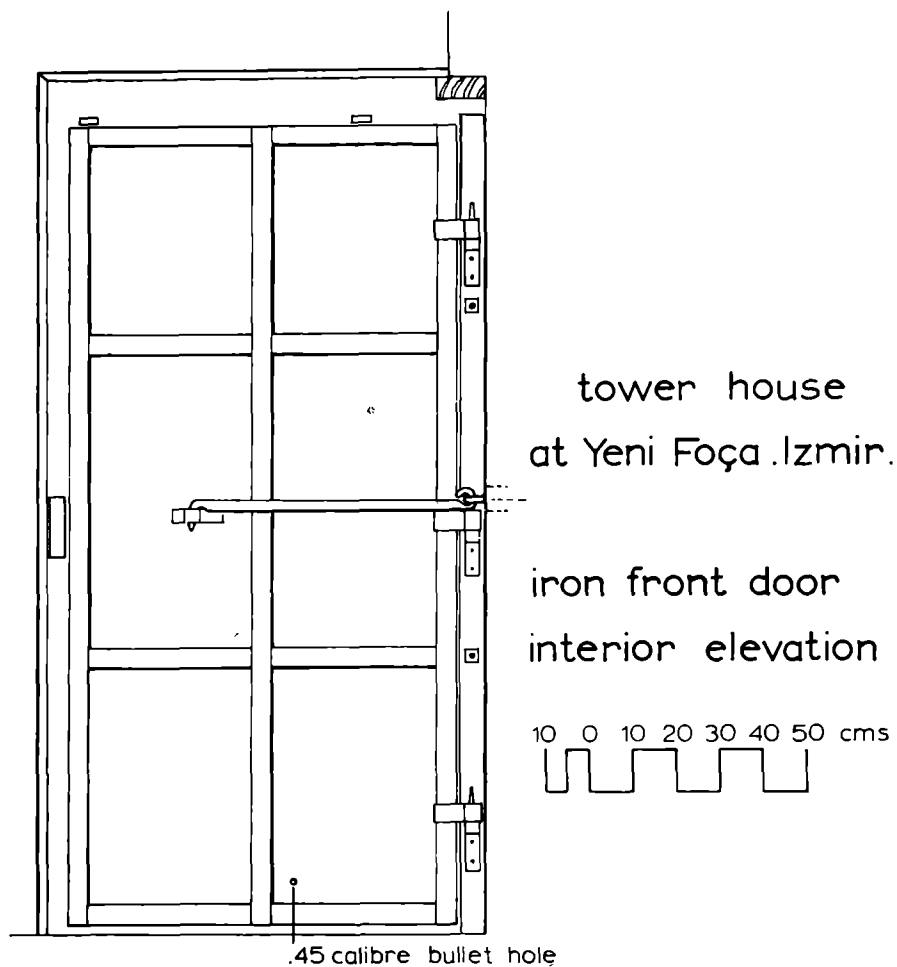
Fig. 8 Iron front door. Interior.
